HUNTER'S WORLDWIDE

Engineering Testing Proves Results

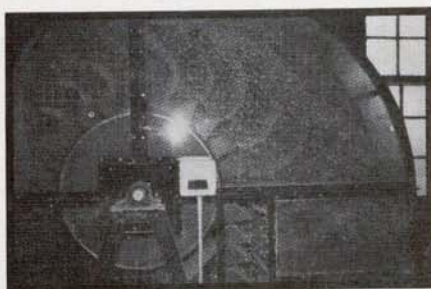
#1 After extensive testing, results show mass movement of grain with a low profile pattern by placing buckets on closer centers to protect grain from damage.
